MAXON: Quality Alert 2020-03-24, BMR Connectors

This Quality Alert is to notify all installers of upcoming changes to our BMR Installation Manual.

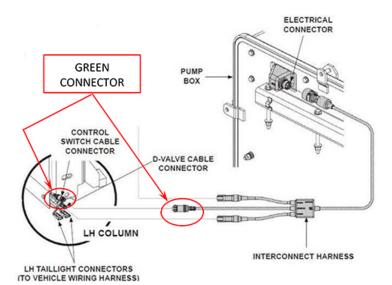
1. Locate GREEN connector(s) from column switch to interconnect harness. The connection is behind the curbside column.

Note: Liftgates with auxiliary or street side controls have a tee assembly with three green connectors. Use procedure on all green connectors.
