## Mainframe Bearing Replacement:

## Lift Arm Bearing Replacement:

## Parallel Arm Bearing Replacement:

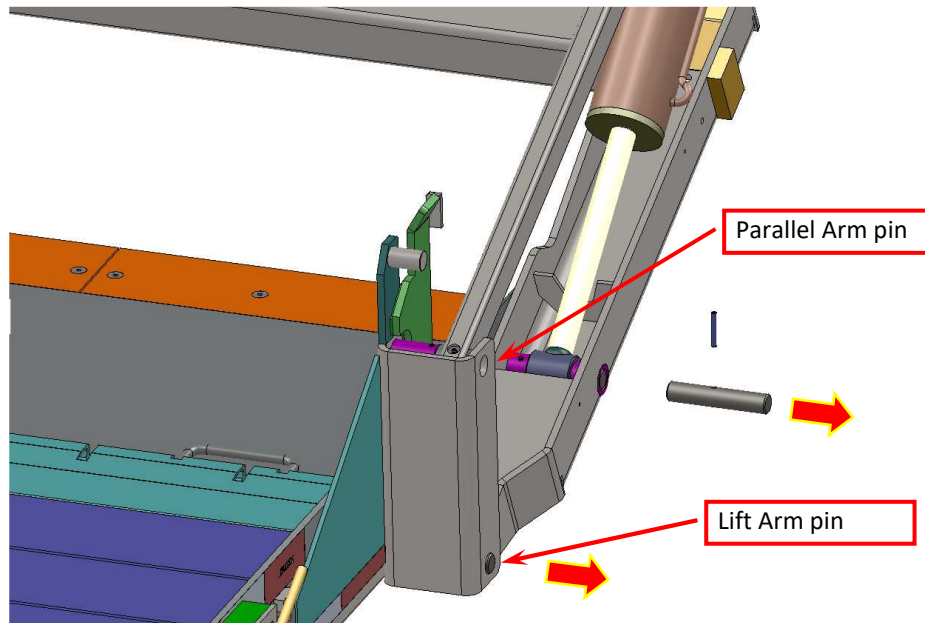
2. Remove Parallel Arm pin and Lift Arm pin from platform on left hand and right hand side of platform. Remove roll pin.

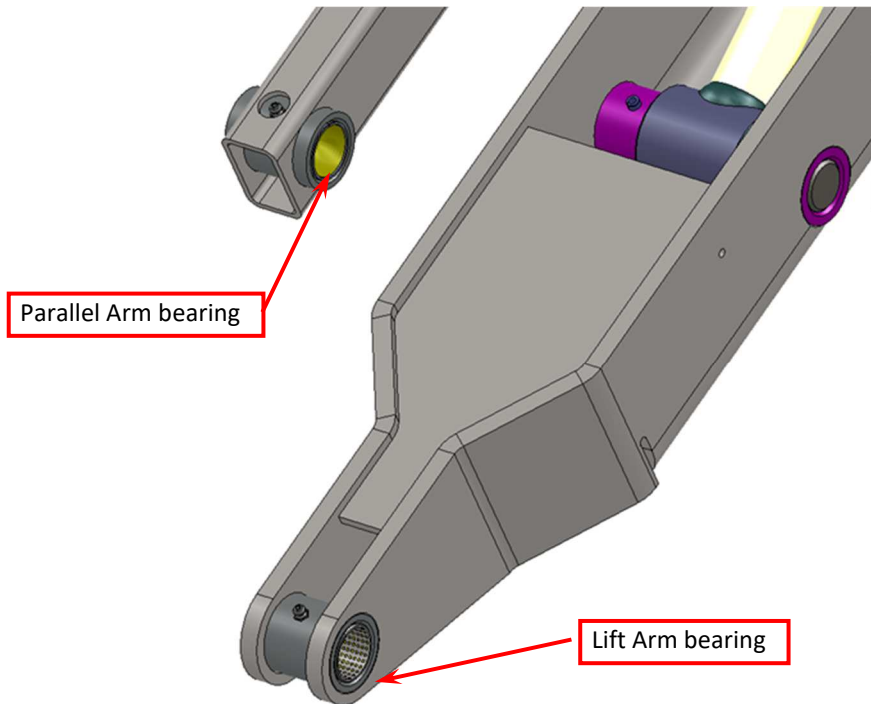
4. Clean inside of bearings on Lift Arm and Parallel Arm.

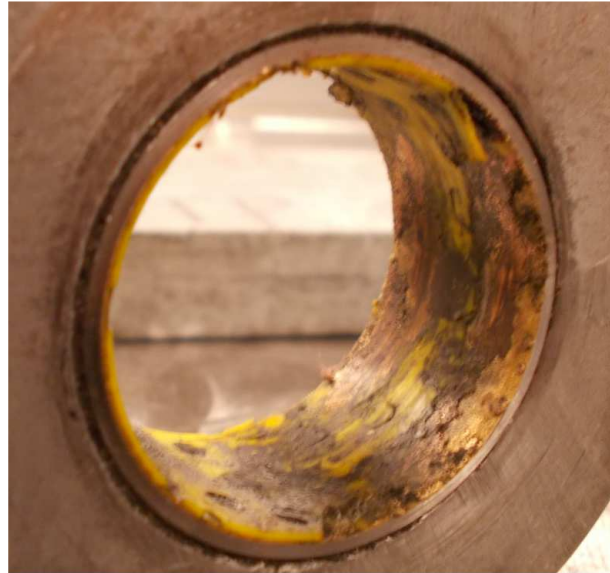
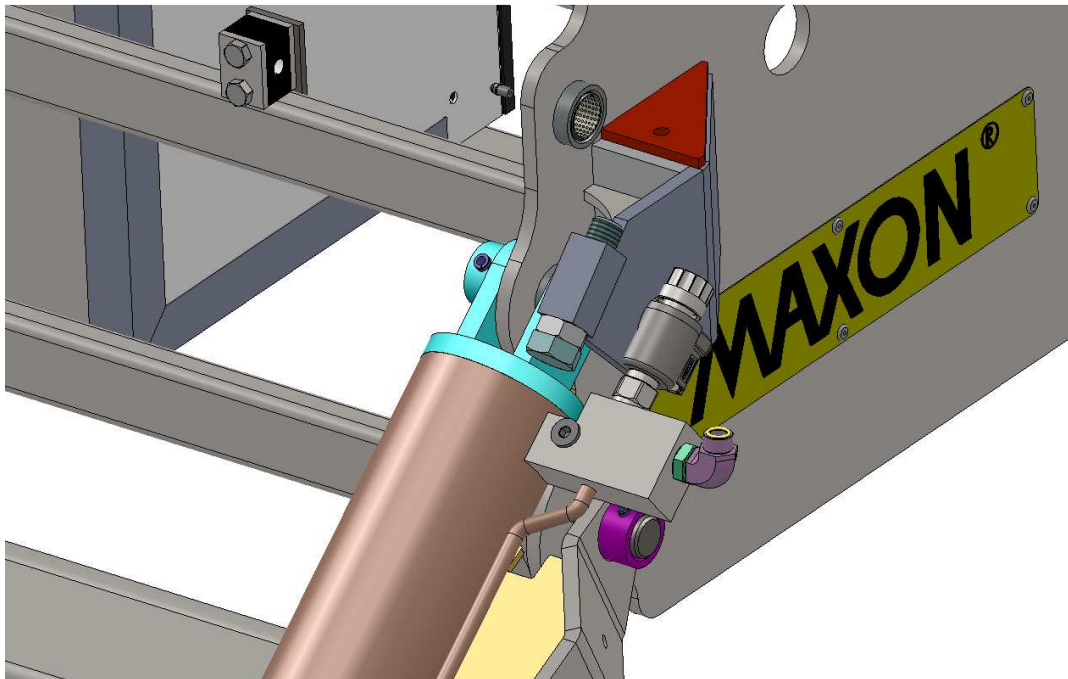
5. Inspect all bearing ID's for damage to the yellow liner. If bearing liner is damaged replace bearing. If bearing liner is in good condition use calipers to check that bearing ID is less than 1.014". Replace bearings with ID greater than 1.014". When a damaged or oversize bearing is found replace all bearings in that component. See bearing installation procedure on pages 5 and 6.

Example of wear/damage to liner

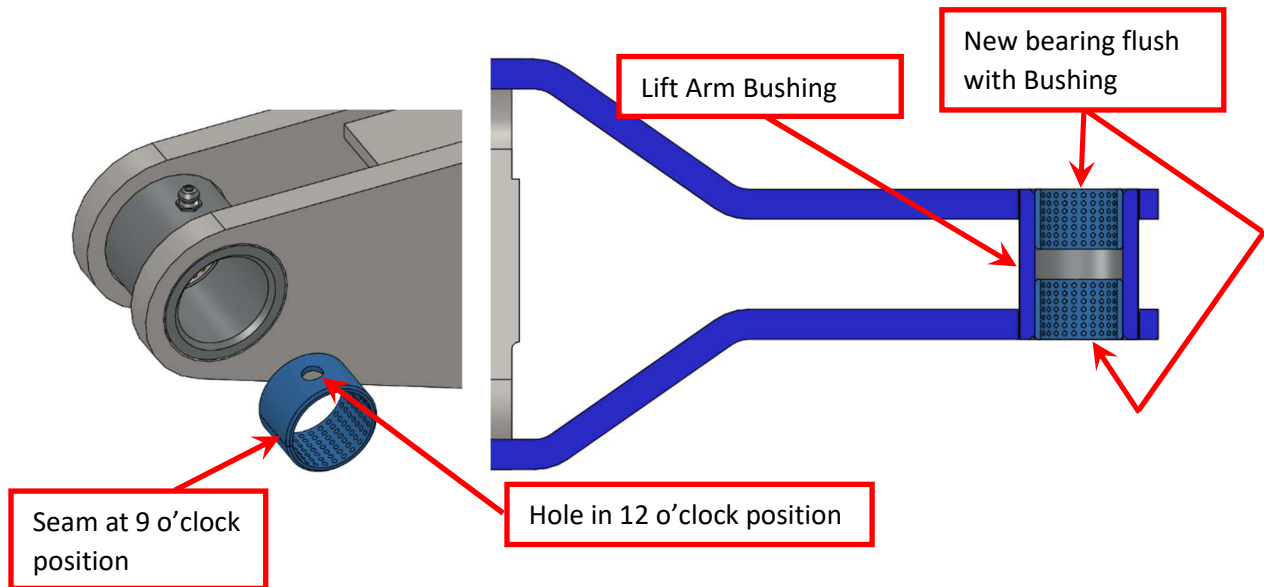
Bearing part # 908178-01

The Lift Arm uses two bearings each pressed in to be flush with the outside of the bushing.

Position Bearing so the hole in the Bearing is pointing upward, 12 o'clock position, and seam in bearing is at 9 o'clock as shown below. Insert Bearing into Flanged Bushing until it is centered in the Bushing.

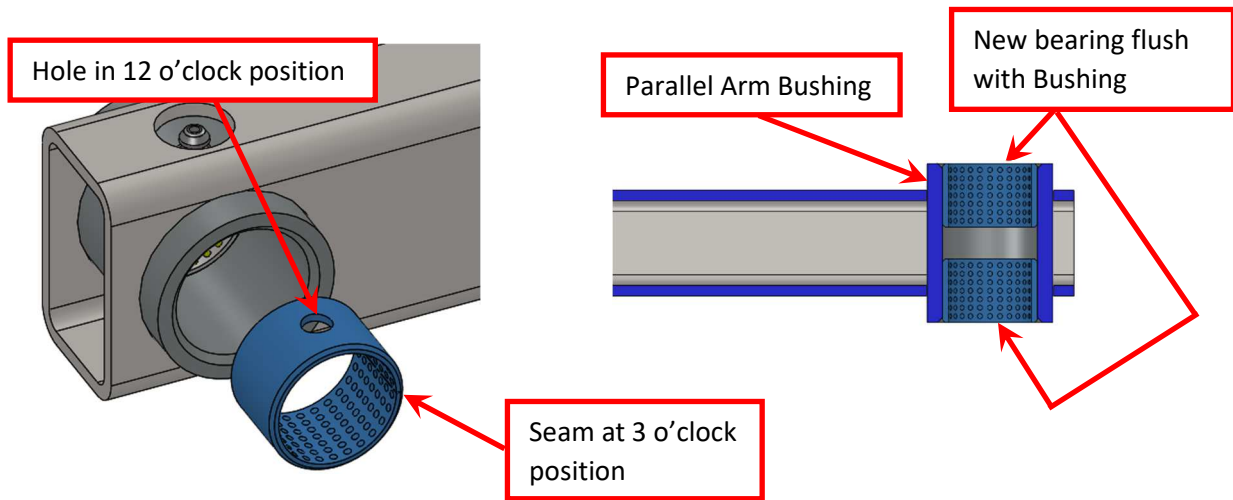
Bearing part # 908178-01

The Parallel Arm uses two bearings, part # 908178-01, each pressed in to be flush with the outside of the bushing.

Position Bearing so the hole in the Bearing is pointing upward, 12 o'clock position, and seam in bearing is at 3 o'clock as shown below. Insert Bearing into Flanged Bushing until it is centered in the Bushing.
